CARLO GAVAZZI CARLO GAVAZZI SPACE SpA	<h1>AMS02-TCS</h1>	DOC N°: AMSTCS-RP-CGS-016 ISSUE : 1 DATE: 02.10.2009 PAGE : 1 of 10
---	--------------------	---

INSPECTION REPORT

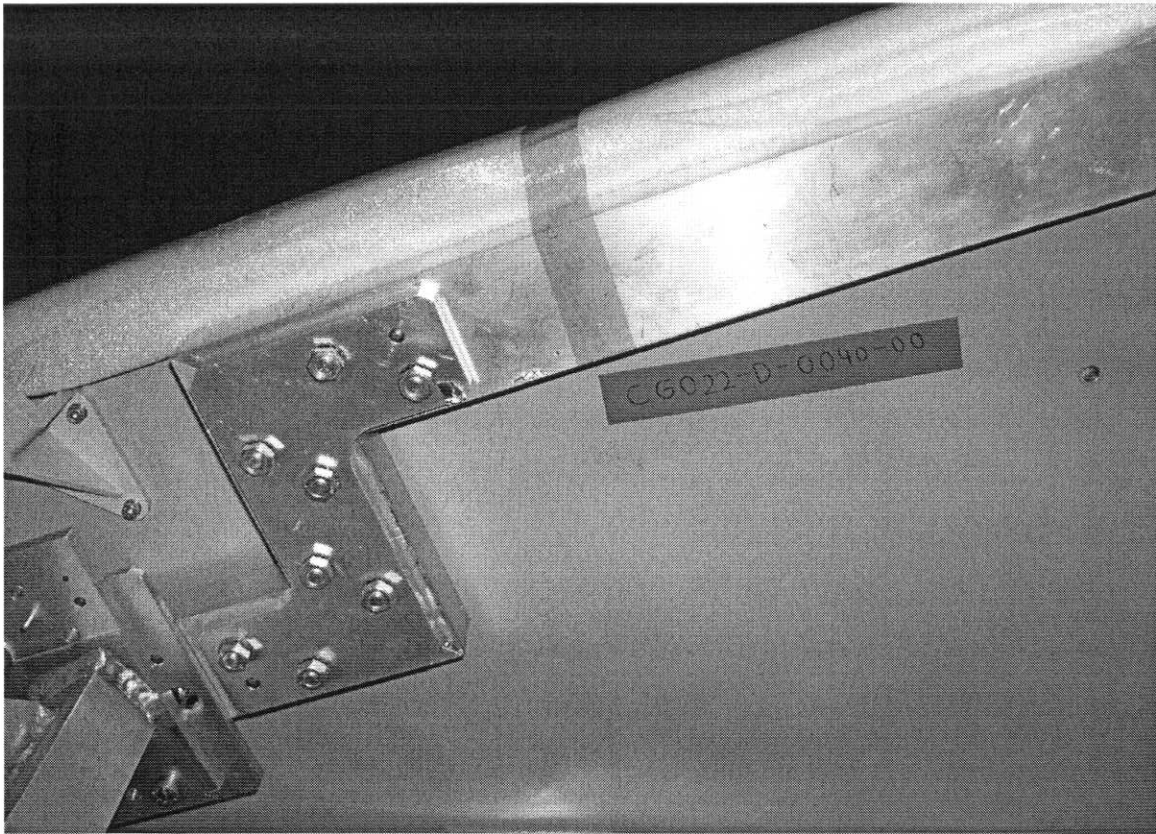
</div> <p style="text-align: center;"><i>Picture 3</i></p>

<p>APPLICABLE DOC. REF.</p> <p>See page 1</p>	<p>PROC. REF.</p> <p>See page 1</p>
<p>ITEM INSPECTED (Name, P/N, S/N) See page 1</p>	
<p>REQUIREMENT SATISFIED</p> <p>See page 1</p>	
<p>INSPECTION (Action/Results)</p> <p><i>The identification labels of the items were placed on the rear side of the radiators (pictures 3 and 4)</i></p> <div data-bbox="167 855 1329 1686">

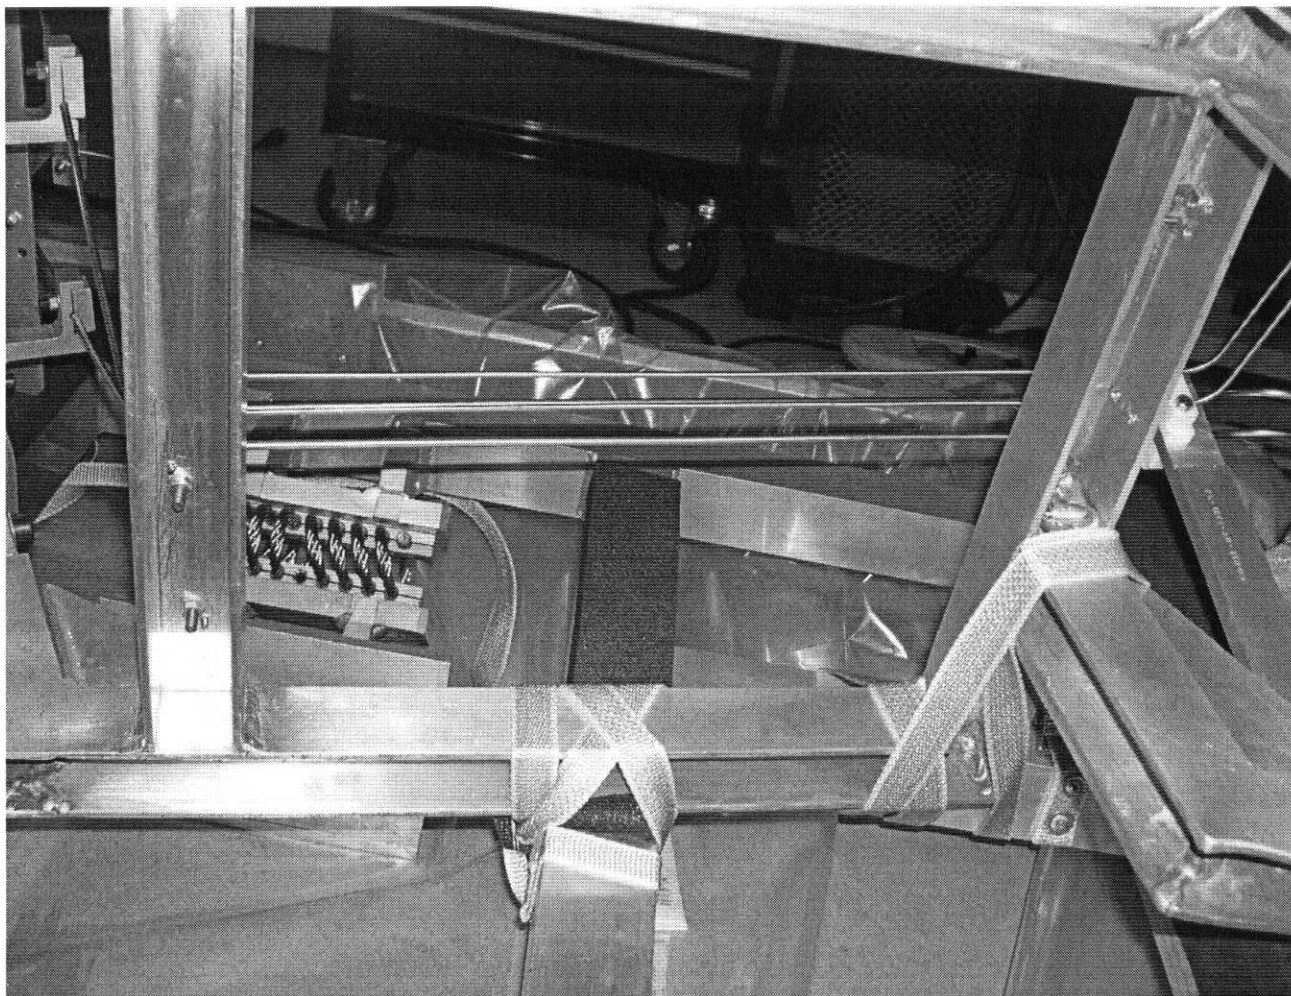
The hardware has been found not properly clean and some parts (along the tubes) have been found with red ink traces

APPLICABLE DOC. REF. See page 1	PROC. REF. See page 1
ITEM INSPECTED (Name, P/N, S/N) See page 1	
REQUIREMENT SATISFIED See page 1	
INSPECTION (Action/Results) <i>Conclusion :</i> <i>The visual inspection has been considered successfully performed .</i> <i>An additional cleaning with Isopropyl alcohol is required .</i>

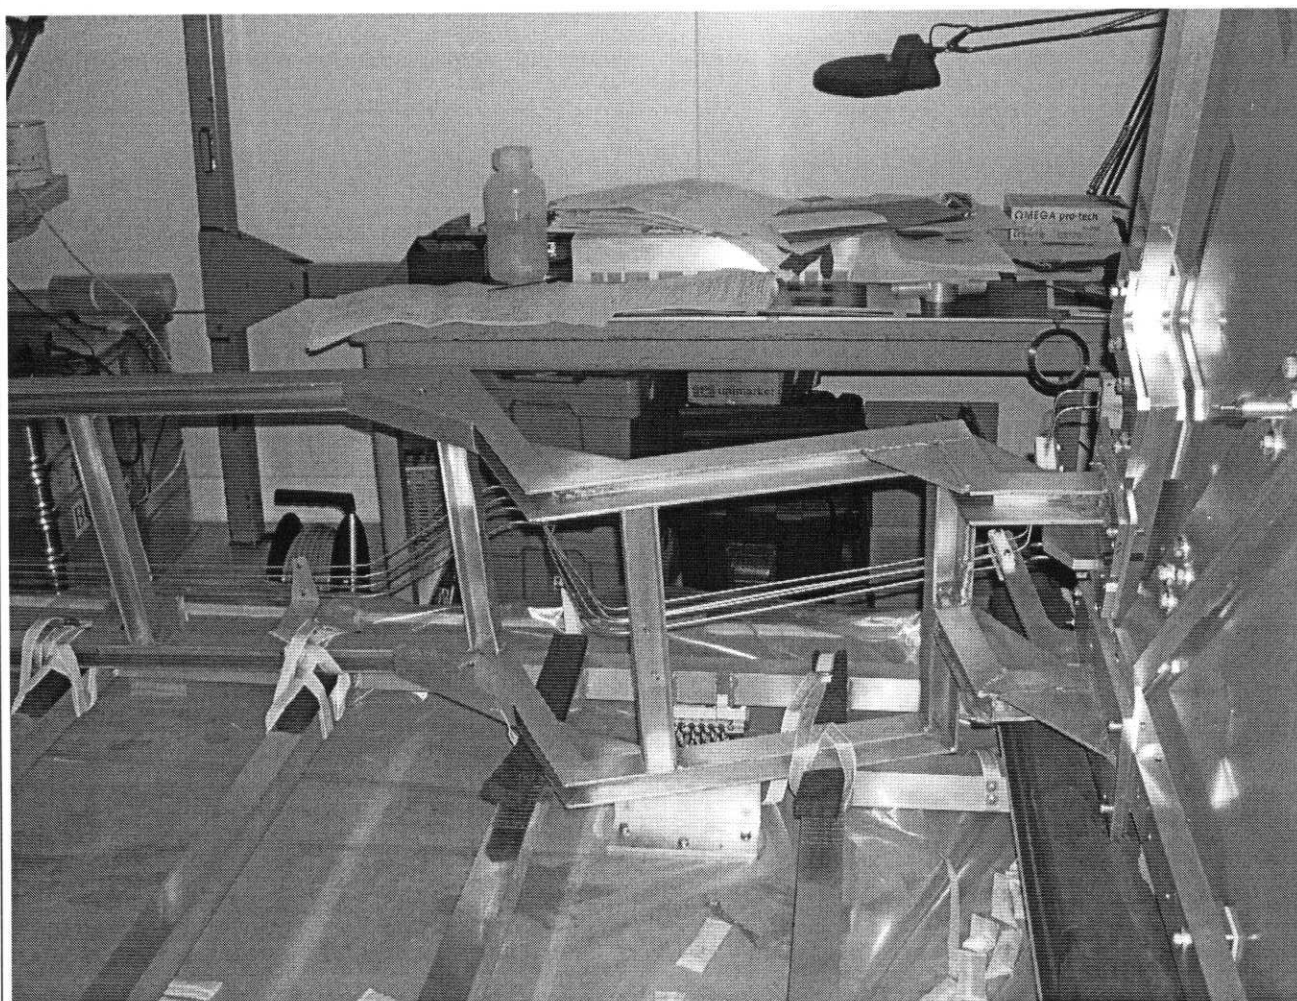
No damages (such as scratches , deformation or bends) have been found.

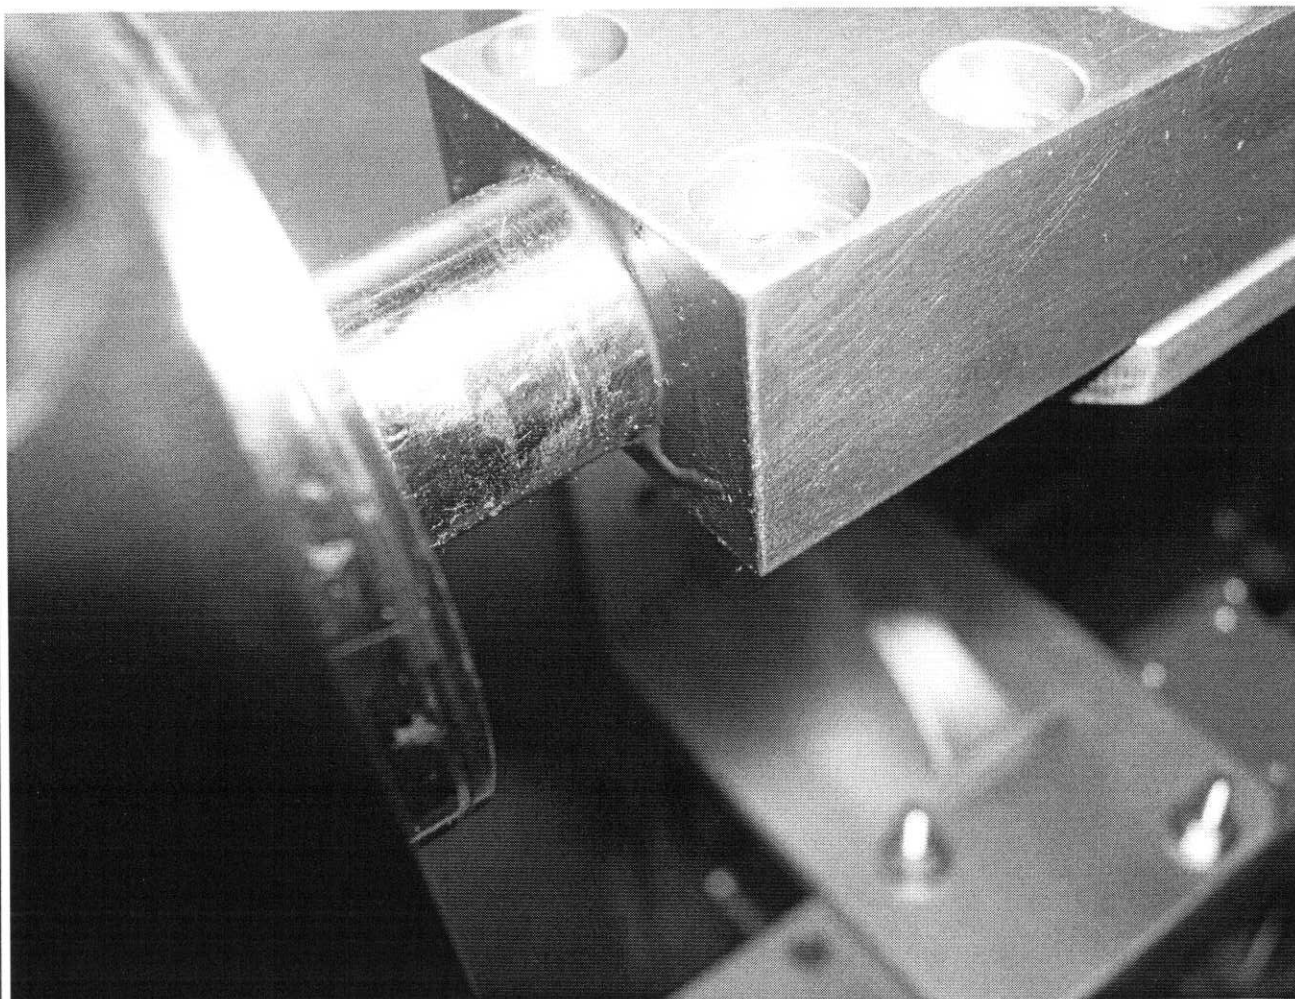
The evaporator saddle have been found sealed

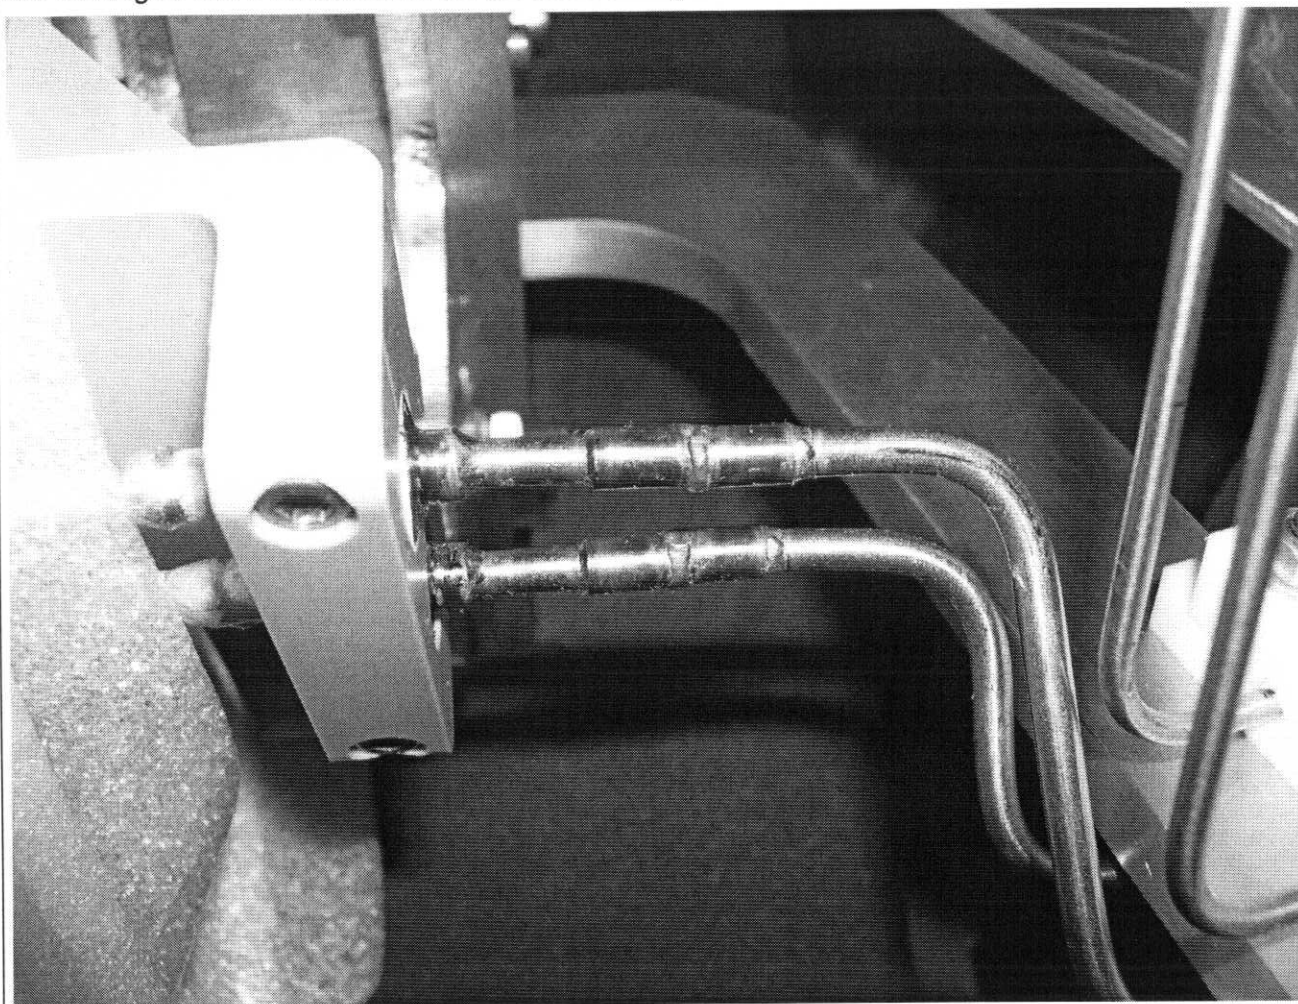
No damages have been found on the blmetallic joints .
